**Subject: South Dayton Dump
Moraine, Ohio
EPA Identification No. OHD 980 611 388
Focused Site Inspection Prioritization
Contract No. 68-W8-0084, Work Assignment No. 35-SJZZ**

**FOCUSED SITE INSPECTION PRIORITIZATION
SITE EVALUATION REPORT**

**SOUTH DAYTON DUMP
1976 SPRINGBORO ROAD
MORaine, OHIO**

OHD 980 611 388

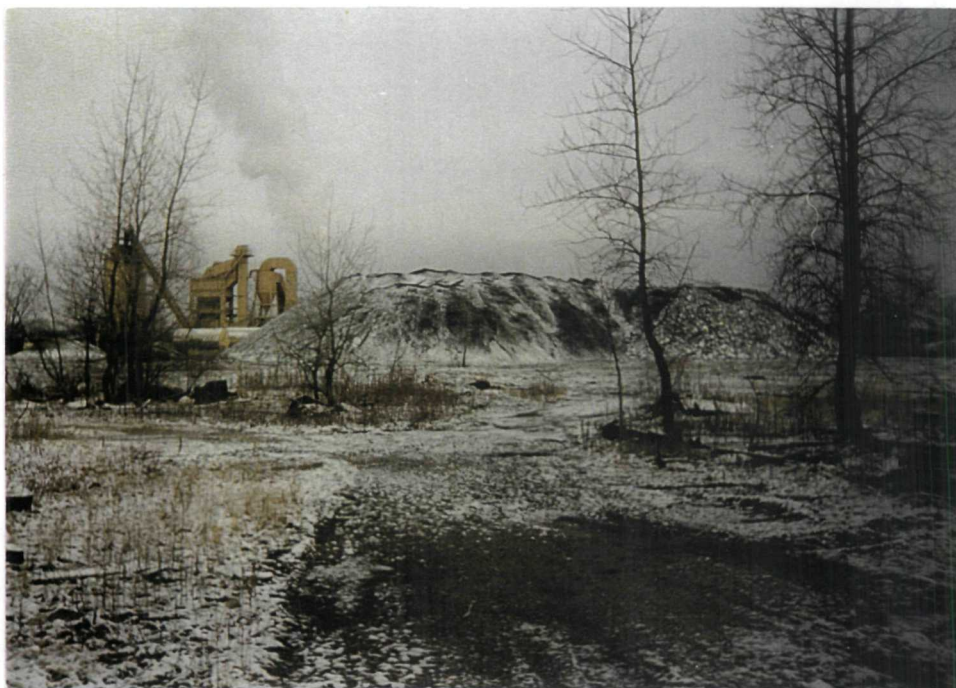
Photograph No. 1

Description: Area of former auto salvage yard north of site, currently used for asphalt storage pile; asphalt plant also shown in left background

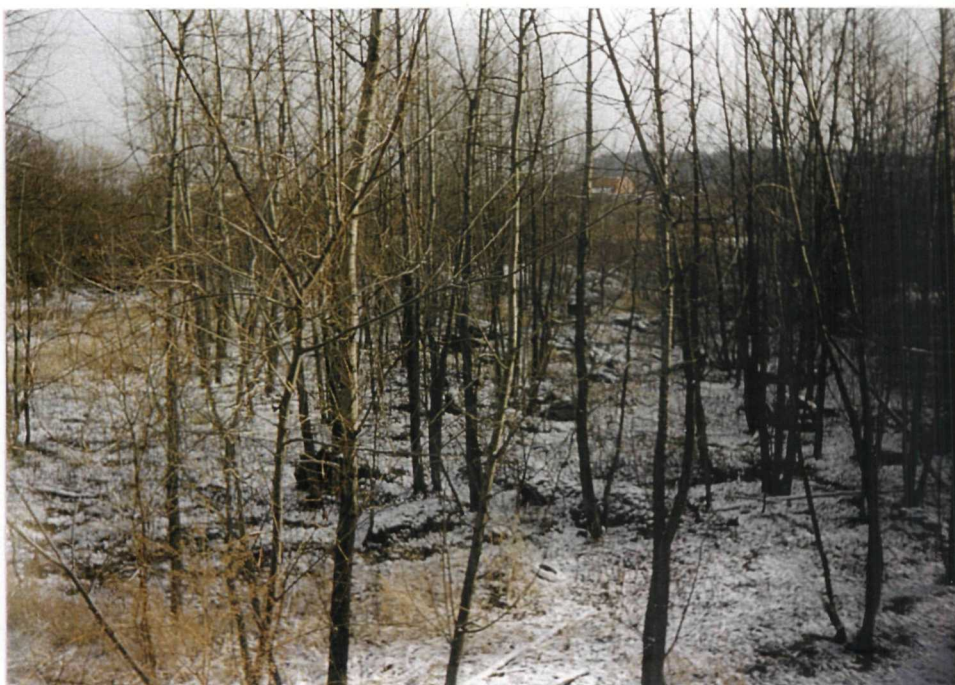
Photograph No. 2

Description: Depression in central portion of site

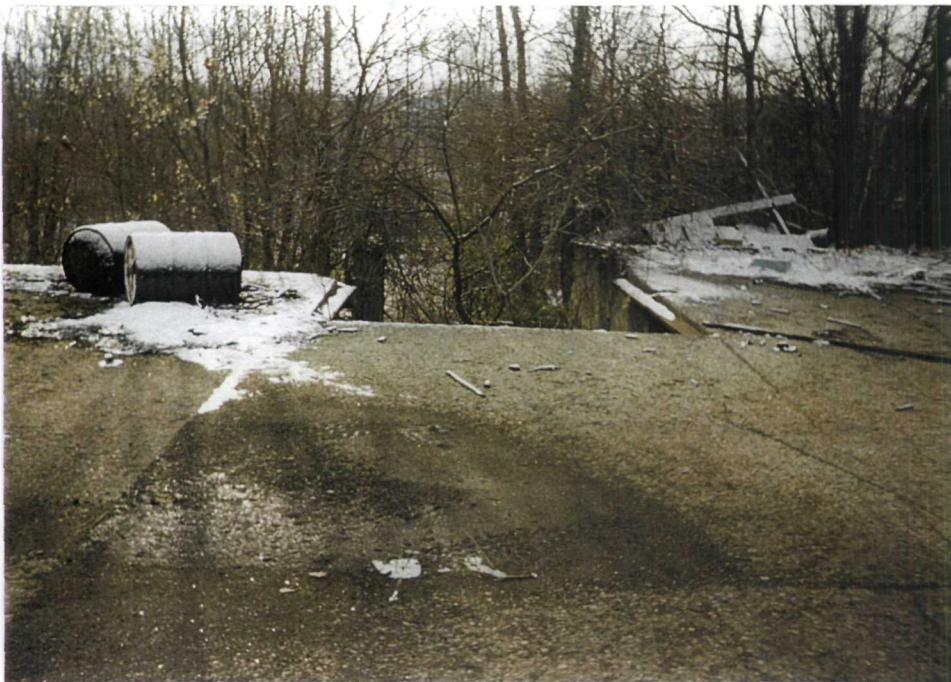
Photograph No. 3

Before 1970, the primary disposal practice at the site was open burning of materials, primarily vegetation and wood wastes. Landfilling was a secondary disposal practice. According to the SSI report, drummed wastes were occasionally accepted at the site between 1950 and 1970. The drums were emptied of their contents and either buried or sold to drum recyclers. Details regarding where the drum contents were disposed of, the types of drummed wastes accepted, the quantities of drummed wastes, and the frequency of dumping are not available because records were not kept (E&E 1991). During its site reconnaissance, PRC noted evidence of several drums, some of which were empty and some that still held their nonliquid contents (see Photographs No. 3, 4, 5, and 8).

Description: Concrete salvage slab along north access road; note empty drums; depression shown in background

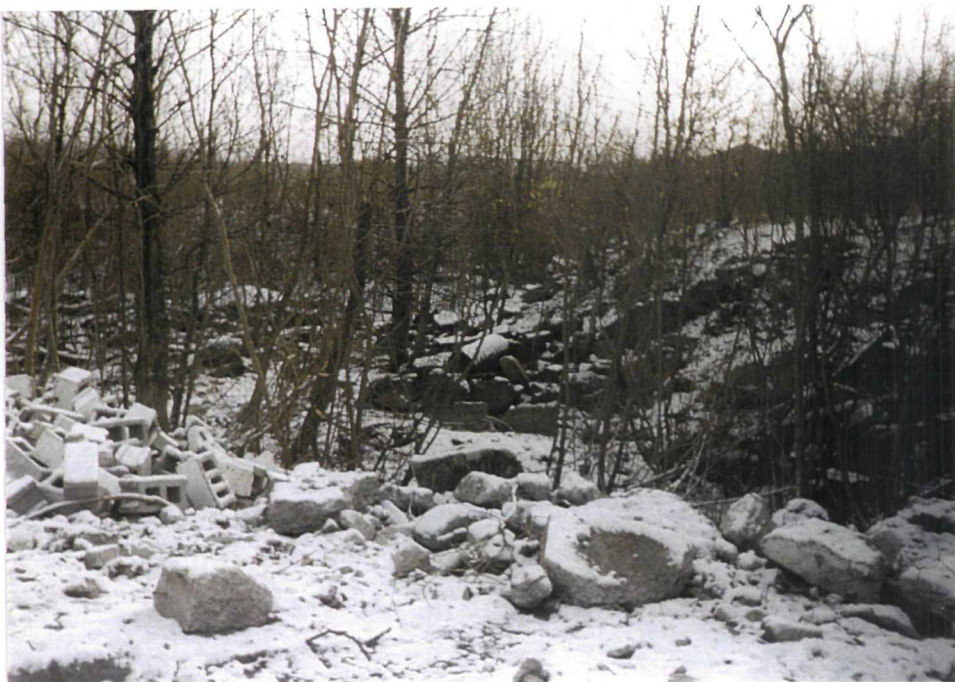
Photograph No. 4

Description: Empty drums and debris in ravine along south boundary of site

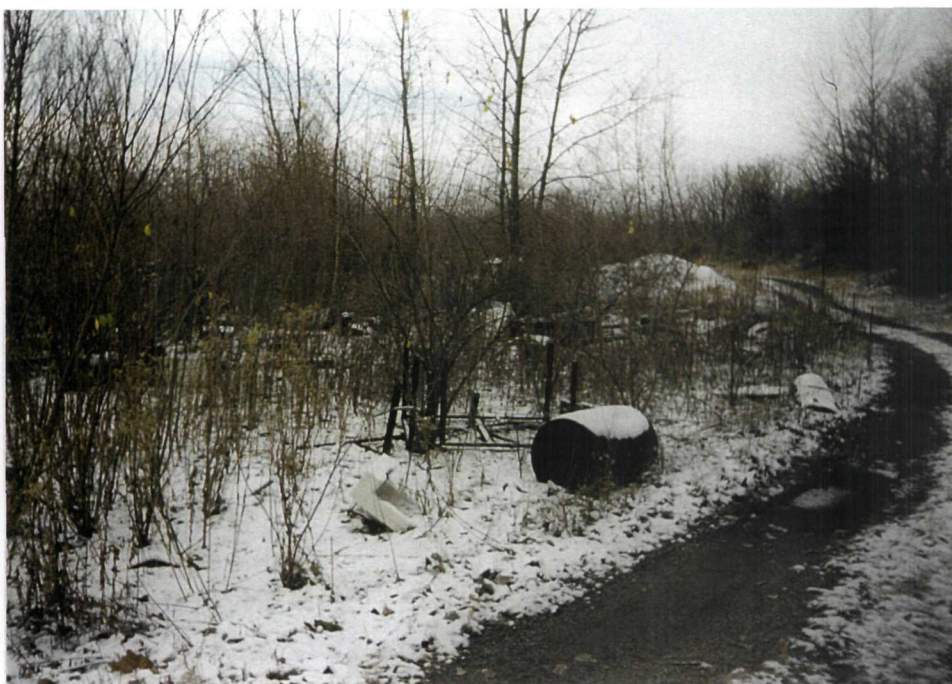
Photograph No. 5
 Orientation: West
 Description: Empty drums along north access road

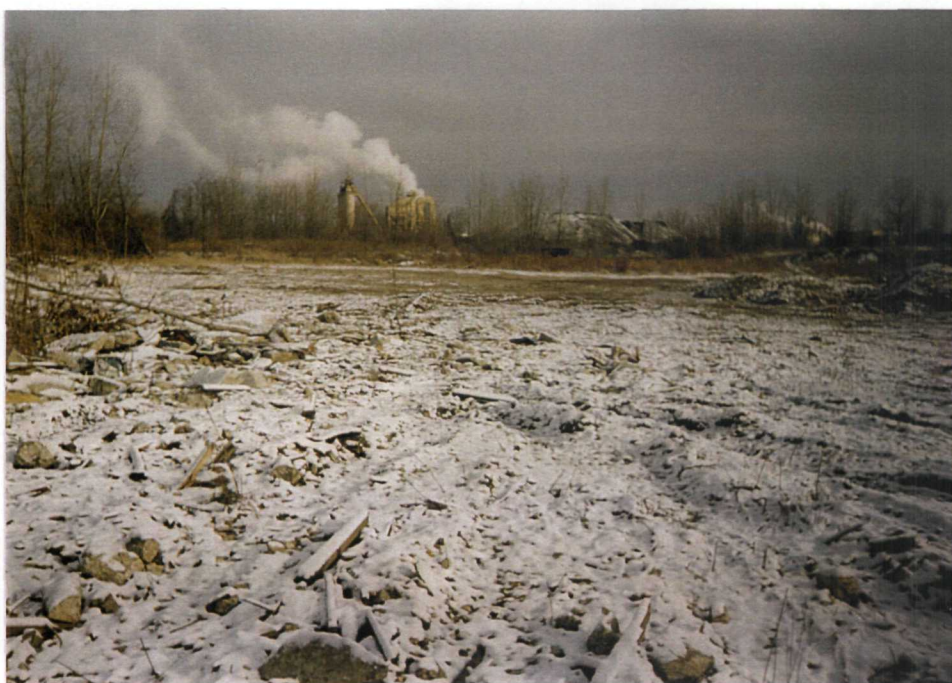
The site is an active dump that occupies about 30 acres of a 40-acre parcel of land. Of the northern 10 acres of the 40-acre parcel, 8 acres was leased to the former auto salvage yard until 1994 and is now vacant except for an asphalt pile, and about 2 acres is leased to a small fabricating company. The site topography is fairly level except for a depression toward the west end of the site (see Photographs No. 2 and 3) and a dry ravine along the southeast border (see Photograph No. 4). A locked entrance gate to the site is located along the east boundary and allows access from Springboro Road. Several trailers, most of which appeared to be abandoned during the site reconnaissance, are located west of the entrance gate. The unpaved north access road extends along the site's north boundary and curves around to the southwest portion of the site (see Photograph No. 5). Another dirt road extends south from the north access road across the center of the site. During the site reconnaissance, the central portion of the site appeared to be the only area of active dumping (see Photograph No. 6 and 7). Figure 2 shows the site layout.

Photograph No. 6
 Orientation: Northeast
 Description: Overview of active portion of site; note construction debris at left; asphalt plant shown in background

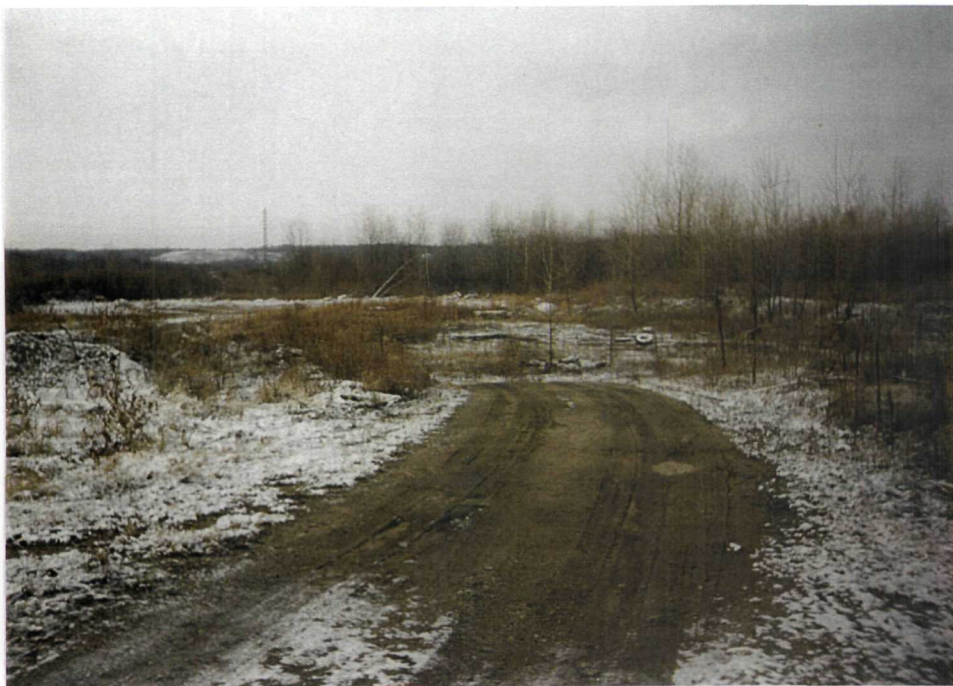
Photograph No. 7

Description: Overview of active portion of site; road shown crosses central portion of site

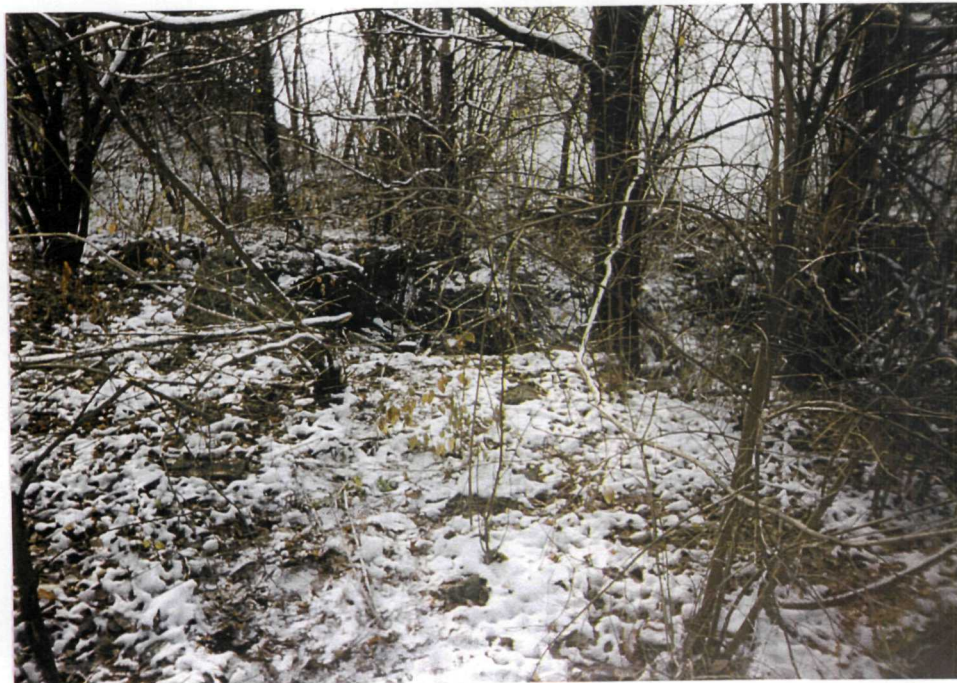
Photograph No. 8

Description: Drums (center of photograph) located along southwest boundary of site; gravel pit filled with water shown in background

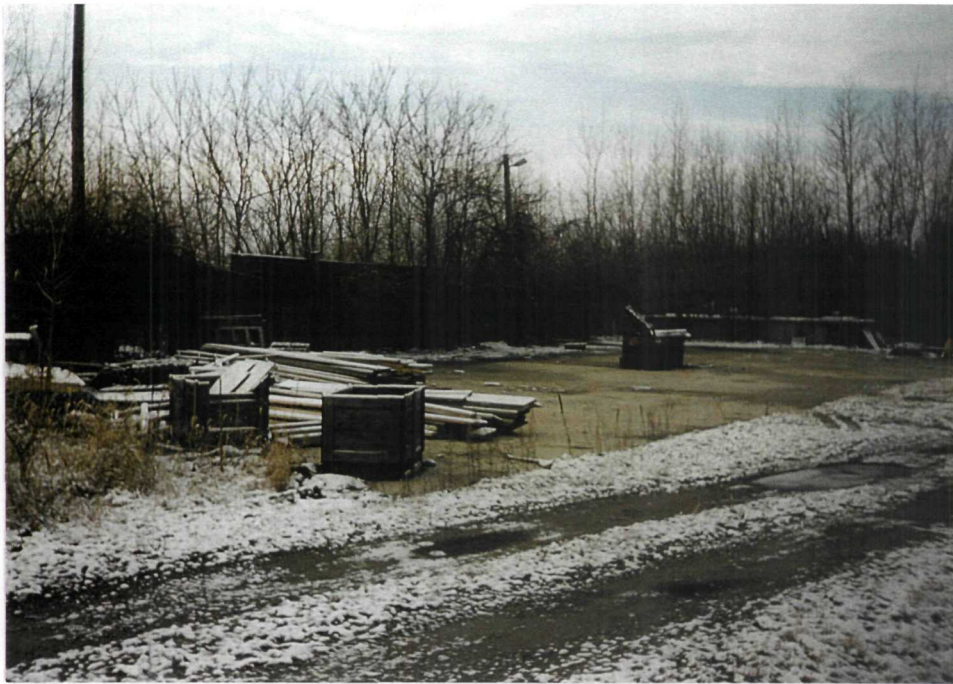
Photograph No. 9

In 1970, because of legislation prohibiting open burning, this practice ceased at the site (E&E 1991). At that time, Alcine Grillot formed Moraine Recycling, Inc. (MRI), which operated on site. MRI developed and constructed a furnace-like device to burn vegetation and wood wastes; the device was called an "air curtain destructor." According to the Montgomery County Combined General Health District (MCCGHD), the device was not an incinerator but rather a "controlled open burning device," and it was to be operated under a special open burning permit (MCCGHD 1970). The Montgomery County Health Department (MCHD) acknowledged MRI's permit application for the air curtain destructor and recommended starting up the device as soon as possible for experimental shakedown. During this period, operation of the device was covered by open burning permits (MCHD 1970). After the permit applications were submitted, several trial burns of the device were initiated. However, because the Ohio Department of Health never granted final approval of the permit, the project was abandoned. During the site reconnaissance, PRC noted that the air curtain destructor was still on site but appeared to be inoperable (see Photographs No. 9 and 10).

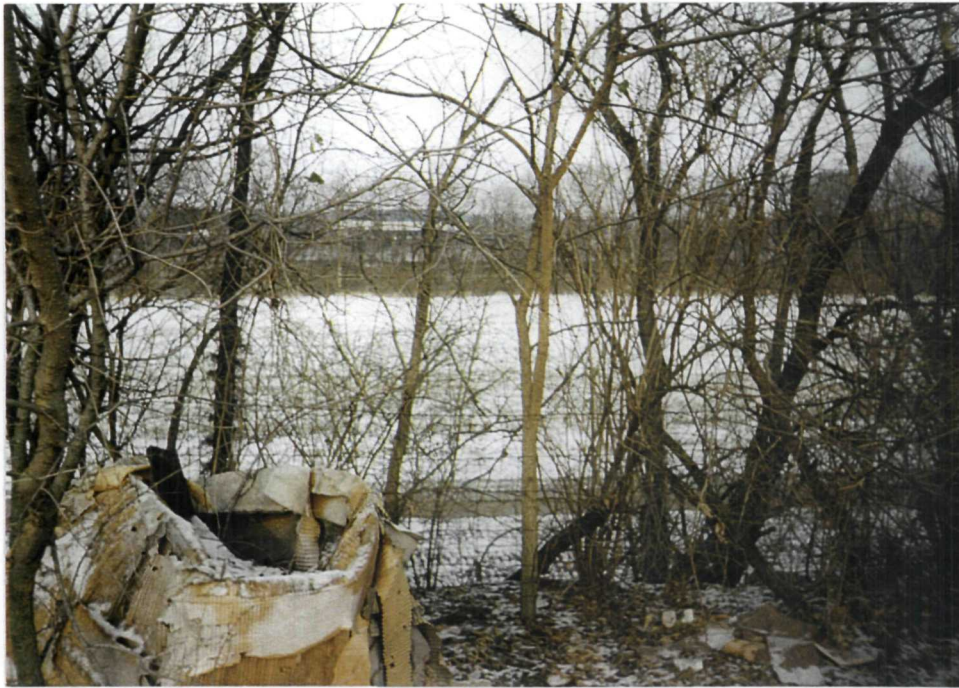
Photograph No. 11

Description: Barbed wire fence along west site boundary; topography beyond fence slopes downward toward bicycle trail; Great Miami River shown in background beyond snow-covered grassy area

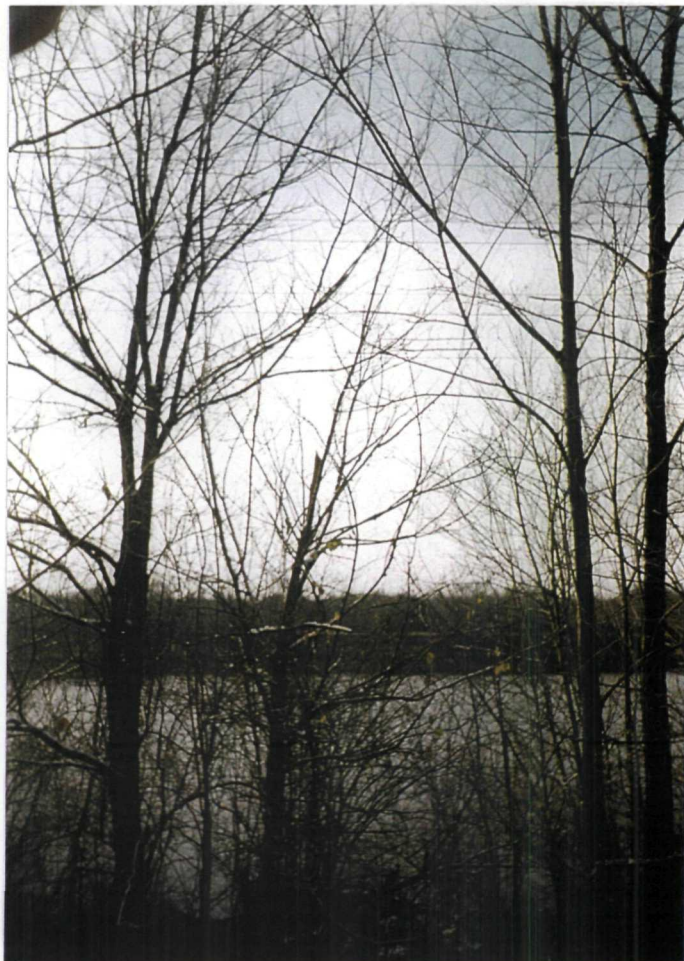
Photograph No. 12

flowing south, which may cause the groundwater flow direction to be more to the west-southwest (E&E 1991). Additionally, based on PRC's observations during the site reconnaissance, groundwater may be discharging to the water-filled gravel pit located immediately southwest of the site.

Description: Water-filled gravel pit; note proximity of pit to southwest boundary of site
